TECH EXCHANGE

All 2005~2007 Models with 3-Cylinder Engines: RS Vector/ER/GT; RS Venture/GT; RS Rage/GT; RS Nytro/ER; RS Vector Mountain/SE; AND VK Professional – Mechanical Cam Chain Tensioner Failure

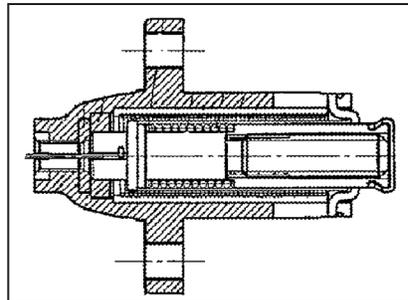
The symptom of loose cam chain tension is excessive rattle noise near the cam chain tensioner while the engine is running.

The damage caused by a loose cam chain tension could be engine damage due to valve/piston contact or severe wear of the cam chain drive gear on the crankshaft.

If any of the above symptoms or damage occurs, make sure the cam chain tensioner assembly is replaced with a new tensioner.

NOTE: The original failed tensioner may function properly when removed and bench tested. If the original tensioner is reinstalled, it will likely fail again causing repeat engine noise or damage.

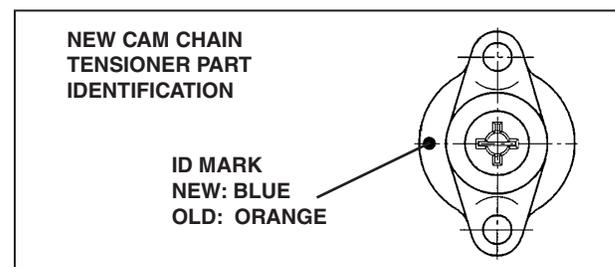
Parts Identification

The tensioner can be identified by a paint mark on the tensioner housing. The new type tensioner is identified with a blue mark; the old type tensioner mark is orange.

The cam chain tensioner was changed for 2008 production. The previous tensioner part number will automatically supersede to the new part. All available tensioners are new type. The old type tensioner is no longer available.
