# Technical BULLETIN

## ALL 2014 SR VIPER MODELS Reverse Actuator Extension Update Kit

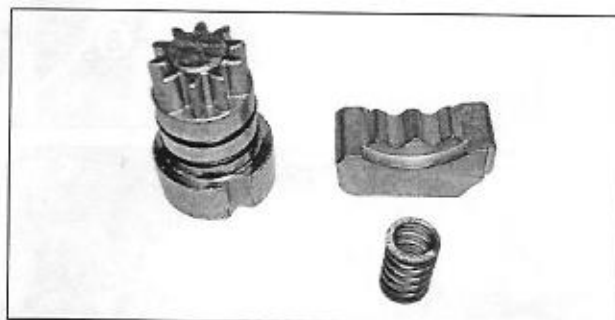
**Symptom:** In affected 2014 SR Viper models it is possible for the reverse actuator to shift out of forward gear which may cause gear damage.

**Remedy:** Install a new Actuator Extension Update Kit. Instructions are included in the kit and provided in this bulletin.
